Bulletin

MARCH, 1955

No. H82-G

MECHANICAL DESIGN CHANGES AND MODIFICATIONS (Engine Oil Pump, Valve Overhead Gear, Clutch Gear Spigot Bearing)

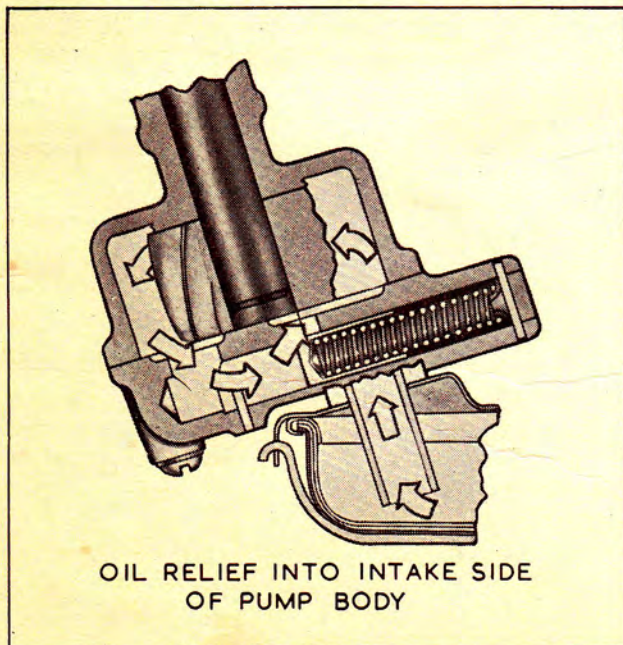
Fig. 2

The oil pump has been re-designed to incorporate helical gears, Fig. 1, and a relief valve with an internal bypass located in the cover and so positioned that when the relief valve opens, the oil passing the valve is directed back into the intake side of the pump, Fig. 2. The helical gears provide for quieter operation, while the design of the relief valve is such that there is little possibility of the valve being held open by foreign matter.

Note: The pump body and cover mating surfaces are in direct contact; no gasket being used on this type pump.

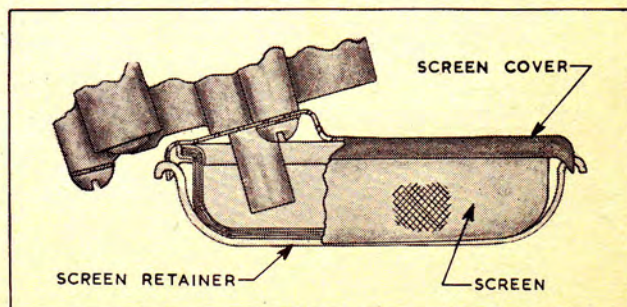
Fig. 3

The oil pump screen and cover have also been re-designed with the object of ensuring that all the oil entering the inlet side of the pump must pass through the close woven wire screen, Fig. 3.

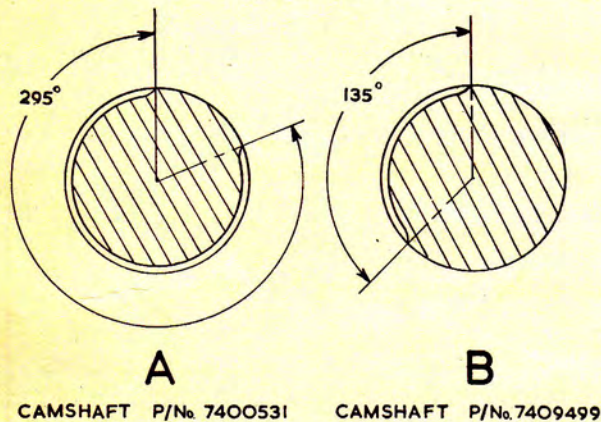
Fig. 4

The oil distribution groove to the valve overhead gear has been reduced in length from approximately $5/6$ ths (295°) of the circumference of the rear intermediate journal, to approximately $1/3$ rd (135°) of the journal, Fig. 4.

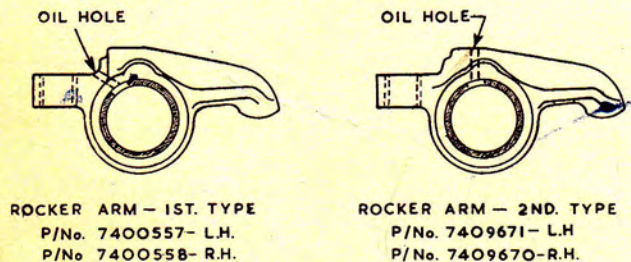
Fig. 5

The valve rocker arms have been modified by re-positioning the oil bleed hole to allow more oil to flow to the rocker arm and valve stem contact, Fig. 5.

NOTE: The new type rocker arms should only be fitted to engines which are equipped with valve seals and the 2nd type camshaft (smaller oil groove), otherwise excessive oil consumption may be experienced due to excess oil passing down valve guides.

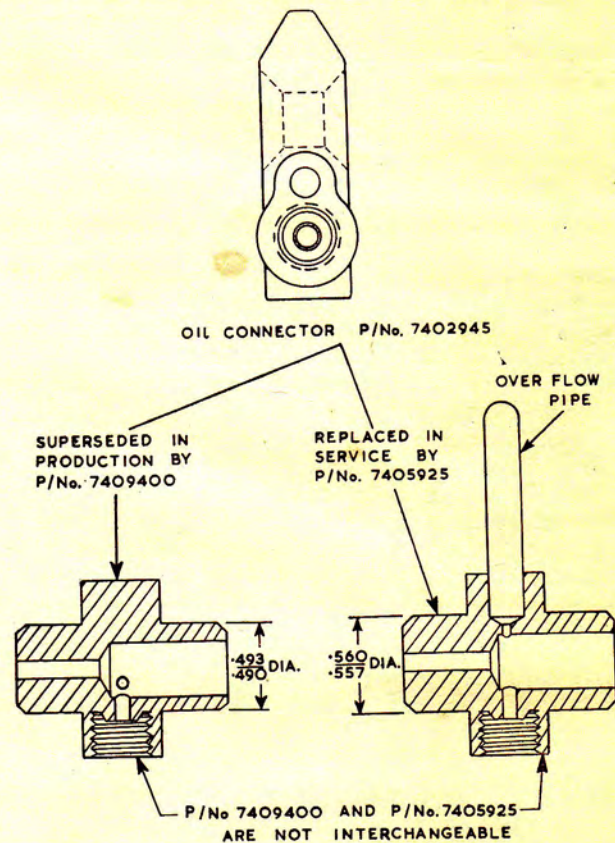
Fig. 6

The rocker arm shaft oil connector, which bridges and distributes oil to the rocker shafts, is now of one-piece construction and so formed that its outer ends enter the inner diameter of both the front and rear shafts, Fig. 6.

Oil flowing to the rear rocker arm shaft is metered by a drilled passage in the connector.

The 2nd type oil connector is not suitable for engines prior to approximately engine No. 197338 and as the 1st type connector will not be serviced when existing stocks are exhausted, a service oil connector, Part No. 7405924, will be made available, which is of the same simplified design as the new connector but varies dimensionally to accommodate larger openings in the ends of the 1st type rocker arm shafts. The service connector is readily identified by a short oil flow return pipe fitted to the body, Fig. 6.

NOTE: The oil connector must always be fitted with the small metered hole to the rear rocker arm shaft so as to ensure correct distribution of oil to the valve overhead gear.
