SERVICE

Bulletin

No. H96-G

EXCESSIVE OIL CONSUMPTION VALVE ROCKER SHAFT OIL CONNECTOR — REWORK

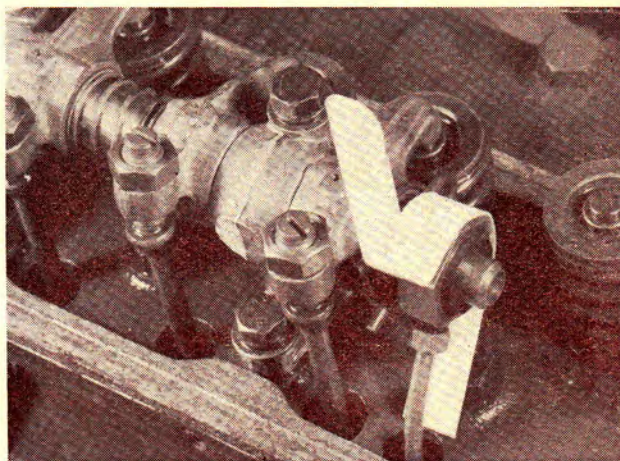
Fig. 1

Investigations carried out on some recent production vehicles reported to be using excessive oil, have revealed that the condition was caused by excess oil passing down the valve guides due to oil splash from the spring coils. The vehicles concerned are above Engine No. 197344, which is the breaking point for the introduction of the 2nd type valve rocker shaft oil connector, Part No. 7409400, and valve rockers, Part No. 7409671—L.H., and Part No. 7409670—R.H.

On all vehicles after Engine No. 197344 which are reported to be using excessive oil, it is recommended that the oil flow to the overhead gear be reduced by increasing the size of the oil relief (over-flow) hole in the oil connector to $\frac{1}{8}$ in. MAXIMUM. This modification should always be carried out and the vehicle re-tested for oil consumption before any major overhaul is attempted.

Note: With the increased size of oil connector relief hole, excessive splash and oil loss may take place whilst adjusting the valve clearance unless some sort of deflector is used. A simple type of deflector can easily be fabricated from light gauge sheet metal $\frac{3}{8}$ in. wide x 6 in. long, shaped so that it can be readily hooked on to the oil connector and will deflect the oil from the connector relief

hole into the centre drain back hole in the cylinder head, Fig. 1. The extended end of the deflector is to prevent the rocker cover being inadvertently replaced with the deflector in position.
